## Impact of Environmental Hazards in Munsyari Block: Kumaun Himalaya

Nisha\* and Jyoti Joshi\*\*

Department of Geography, Kumaun University S.S.J. Campus, Almora-263601 (Uttarakhand)

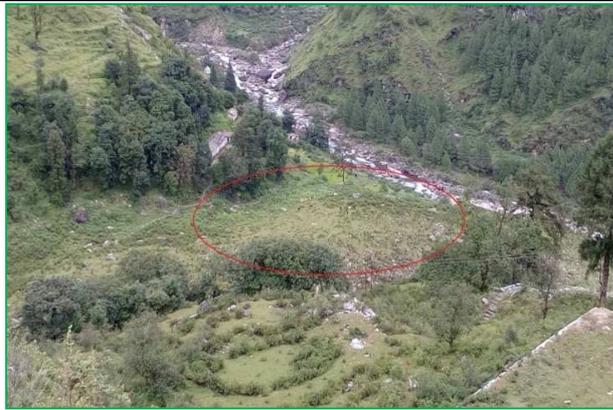
village was totally demolished due to the disasters. Houses and agricultural land of the villages were converted in the barren land as seen in Fig.-2. 15.14 % of the forested land, 19.12 % of the agricultural land and 21.82 % of NAP land was again devastated in the year 2013-2014. In Jhekla village several debris channels flowed down slopes, changing a large part of the village area into ruins (Fig. 3) and damaged mainly agricultural land.

**Fig. 2: Laa Village Devastated By Cloudburst**

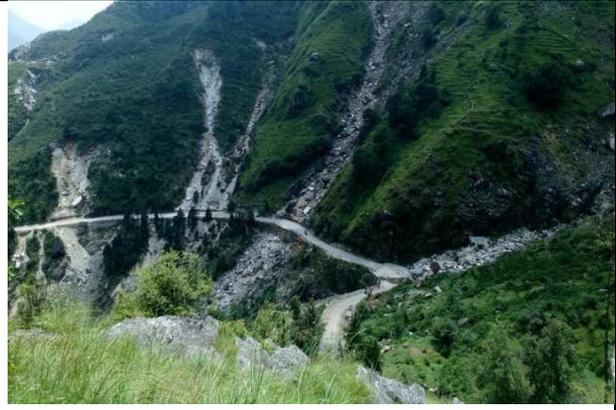
**Fig. 3: Debris Channel Flow In Jhekla Village**

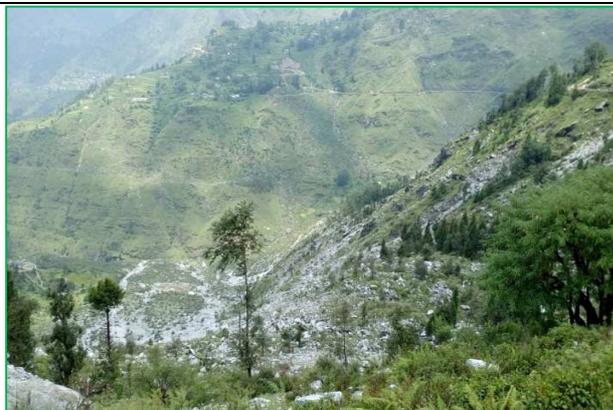
**Fig. 4: Girgaon**

Girgaon was also one of the villages which were devastated due to disasters in recent past 10.09 % of the total forested land, 5.46 % of the agriculture land and 9.22 % of the NAP land was damaged because of the disasters in the village. Forested and NAP land of Girgaon was damaged by debris flow as seen in Fig.-4. Similarly, 3.73 % forested land, 4.22 % agricultural land and 3,84 % NAP land of village Bansbagadh; 7.16 % forested, 13.09 % agricultural and 12.62 % NAP land of Timtiya village; 4.81 % forested, 8.40 % agricultural and 10.27 % NAP land of TallaBainskot village; 2.46 % forested land, 2.03 % agricultural land and 17.74 % NAP land of Gini village; 6.9 % forested land, 10.96 % agricultural land and 11.20 % NAP land was ruined due to disaster (Table-4 and Table-5).

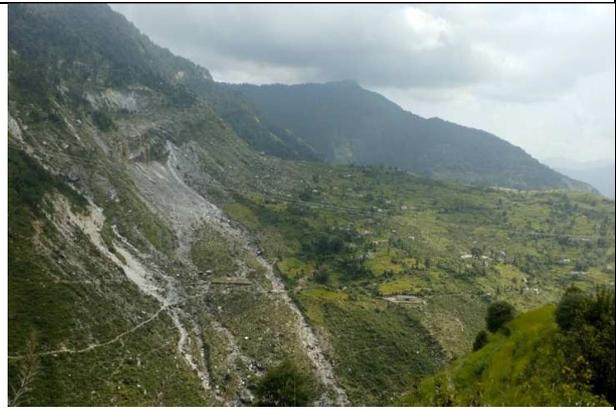
**Fig. 5: Damaged Forested and Agricultural Land Of Gini**

Most of the agricultural and forestland of Gini village affected by debris flow (Fig.-6). Ruisapata was totally damaged and the terraced agricultural fields were flattened (Plate- 7 and Plate-8).

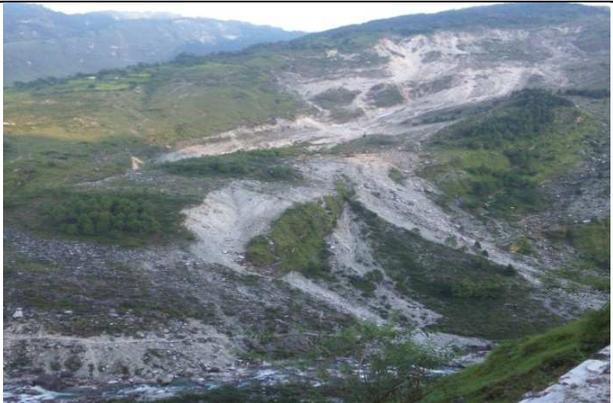
**Fig. 6: Damaged forested land in Ruisapata**

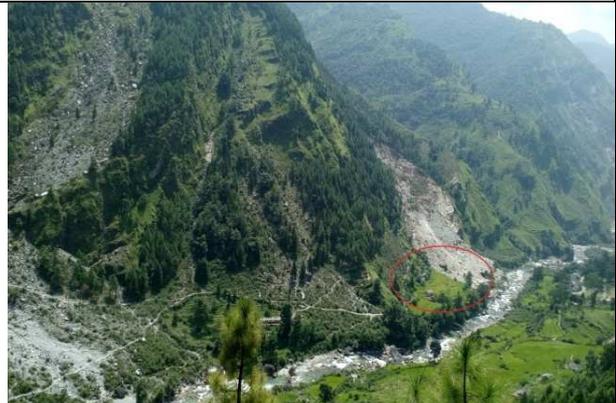
**Fig. 7: Damaged Agricultural Land In Ruisapata**
